Marine Radar for Improved Ice Detection

Barbara J. O'Connell Canadian Coast Guard Ottawa, Ontario, Canada Barb.OConnell@dfo-mpo.gc.ca

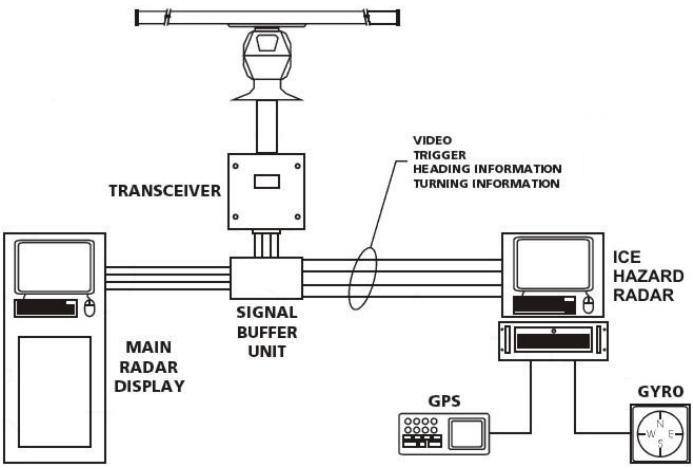
Figure 1 - Radar Configuration

The Ice Hazard Radar display system was installed in the navigation consol of the CCGS *Henry Larsen* in June 2006. It consists of a monitor, computer, the "sigma S6" MRI and software produced by Rutter Technologies Inc, St. John's, NL, Canada. Figure 1 shows the radar configuration. The Ice Hazard Radar display was connected to the vessel's Bridgemaster II x-band radar in slave mode for the 2006 trial.

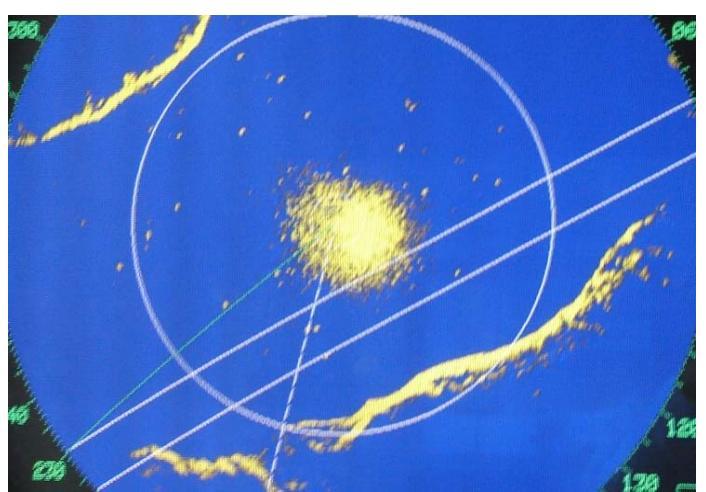
Figure 3 – Standard x-band radar image of Thule Harbour, Greenland.

The analog signal from the x-band radar is processed by the sigma S6 and displayed as a 12-bit digital video image (1024x1024). Figure 3 is a photo of the standard x-band radar. Figure 4 is an image taken of the ice radar. The CCGS *Henry Larsen* (shown in Figure 5) is at the centre of the radar screen. The comparison between these two images is striking. With the Ice Hazard Radar, the coastline is more clearly defined; icebergs are visible at greater distances, as are the smaller bergy bits and growlers. Shadows are visible behind icebergs on the Ice Hazard Radar, caused by the lack of radar returns behind a high target.

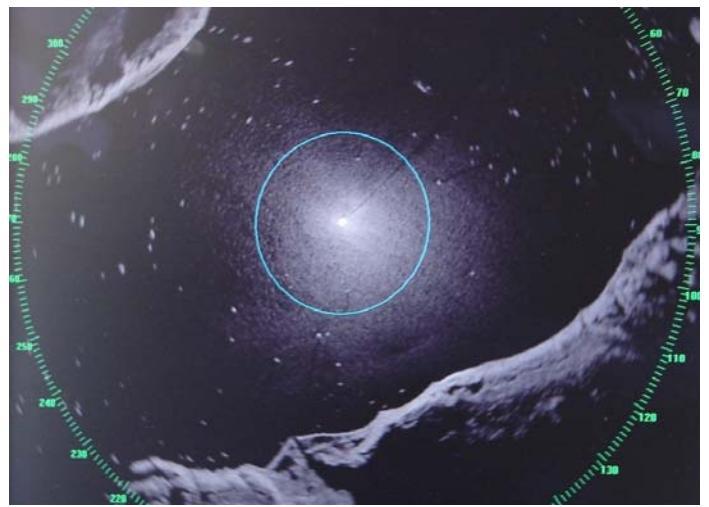
Figure 4 - Ice Hazard Radar image of Thule Harbour, Greenland.

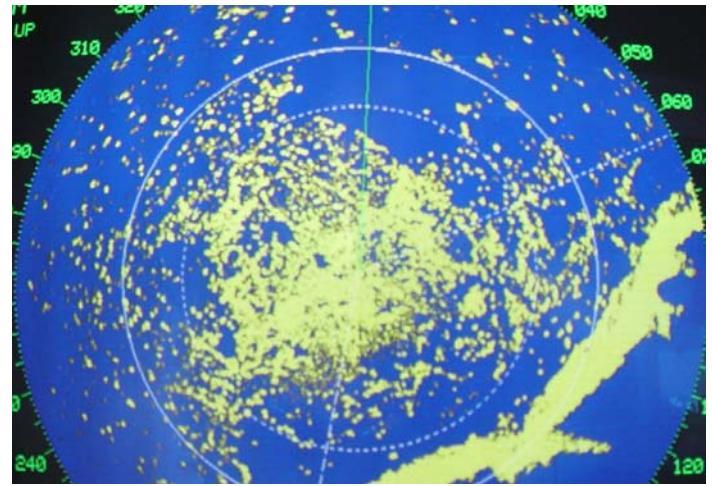
Figure 6 - X-band radar image of multi-year ice in Kennedy Channel off Greenland.

The shapes of ice floes, the ridges and rafted ice and open water leads are also more distinct in the Ice Hazard Radar, particularly when using the short radar pulse length (see Figures 6 and 7).

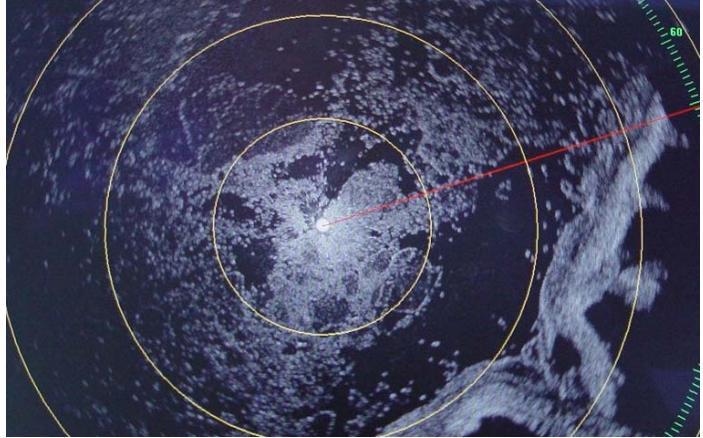
Figure 7 – Ice Hazard Radar image of multi-year ice off Greenland.

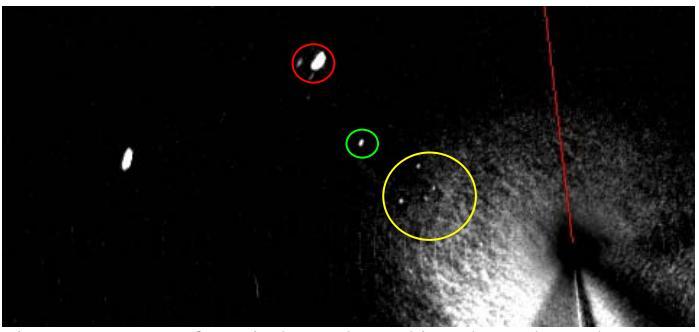
Figure 9 – Image of two icebergs, bergy bit and growlers. The nearest iceberg is 3.6 n.m. The bergy bit (centre) is 2.75 n.m. The cluster of growlers range between 2 and 1.5 n.m. from the vessel. Wind 10 kts.

The high-speed radar, together with the advanced radar processing techniques such as scan-to-scan averaging (up to 128 consecutive radar scans), was able to detect large targets such as vessels and icebergs at longer ranges than the conventional radar. When rotating at 120 rpm, it was also able to detect bergy bits and growlers from decaying icebergs at more than three nautical miles (seen as smaller spots in figure 9). The growlers were not detected by the standard radar until about a half mile away.

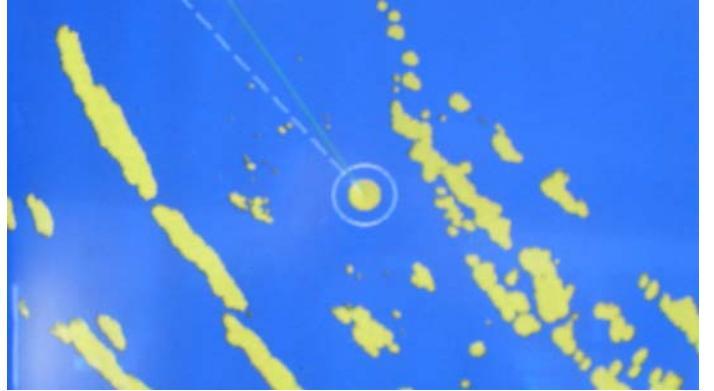
Figure 10 – X-band radar image of Pike Resor Channel.

Ice floes are more distinct with the Ice Hazard Radar than with the conventional x-band radar, particularly when using the short radar pulse length (compare Figures 10 and 11). Captain Broderick commented "The Ice Radar proved a great advantage while navigating through the icebergs in reduced visibility. Consistently we were able to detect the bergs at a greater range with the Ice Radar. This allowed us more time to determine the best route through high concentrations. Additionally we were able to differentiate between the size of bergs and bergy-bits. Our navigational radars could not give us the long range detection nor the resolution and definition. I will give this year's version of the Radar Project an excellent review and I hope we can continue to improve on the present set-up."

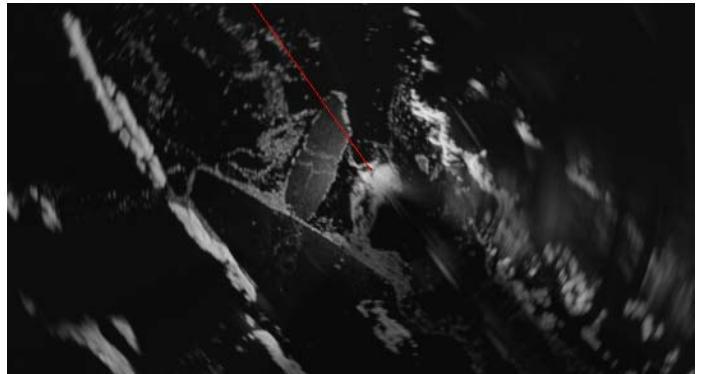
Figure 11 - Ice Hazard Radar image of ice in Pike Resor Channel.

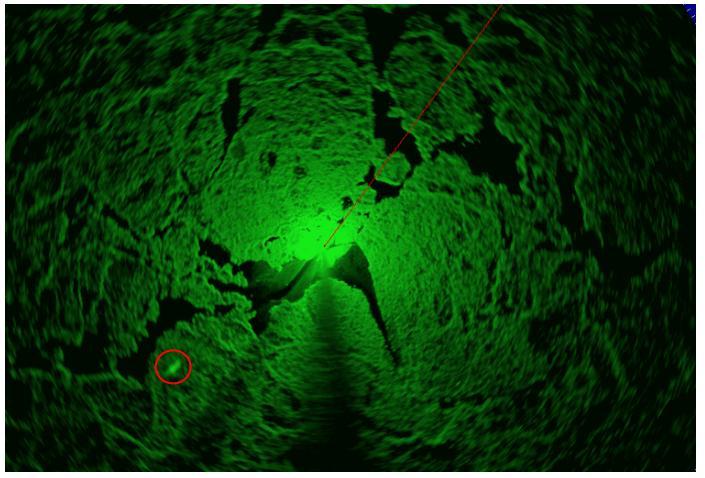
Figures 16 and 17 compare the images of the enhanced radar and conventional radar.

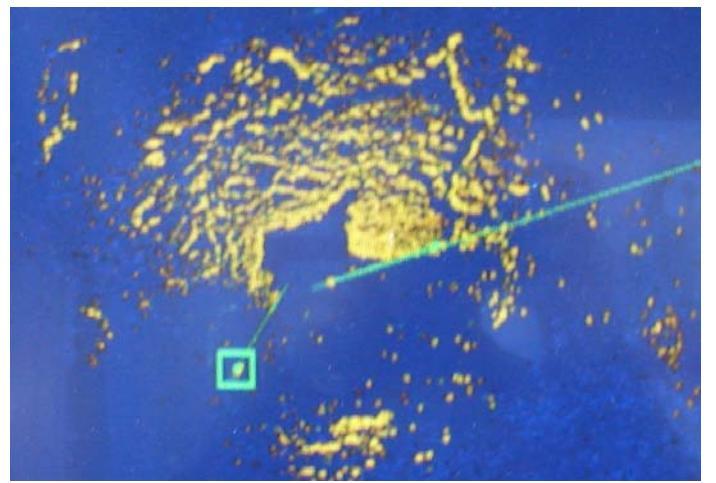
Figure 17 – Escort of cargo vessel (in the square) on the x-band radar.

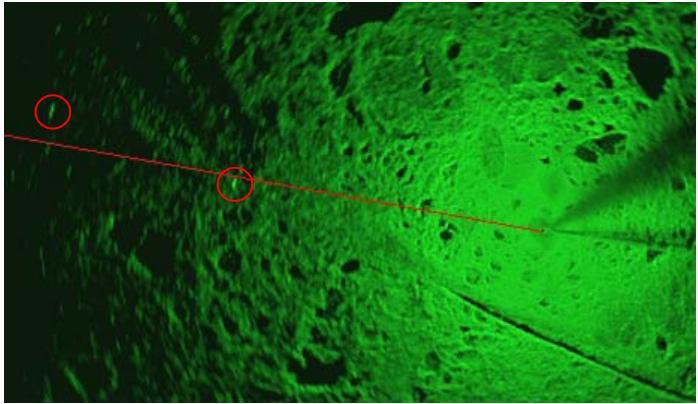
Figure 18 - Image of the two small fishing vessels requiring escort.

Night navigation can be difficult in ice under pressure with searchlights and the use of radars. (Figures 18 and 19) Two small fishing vessels became trapped in the ice after following the track of a larger vessel. The icebreaker was able to proceed without any problems to the boats and then escorted then one at a time to the ice edge.

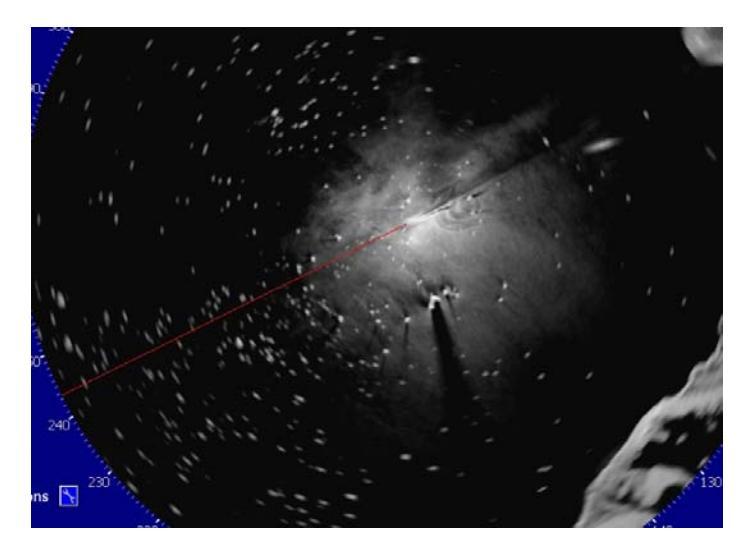
Figure 20 – An image of "Iceberg Alley" on the 3 mile range.

The high-speed radar scanner also has the ability to detect small ice objects in various sea states far earlier than with conventional radar systems and visual detection. There are 24 hours of daylight in the Arctic during the summer months; however periods of fog, snow and poor visibility are quite common. The risk of ice damage to vessels will be reduced if they can detect dangerous ice in sufficient time to avoid it. Figure 20 shows numerous icebergs and bergy bits off the Greenland coast.
